# Dairy Industry Bungalow II (Building 160)--Beltsville Agricultural Research Center

Location: Beltsville, MD (Prince George's County)

Date of Construction: c. 1933

Maryland Historical Trust Inventory Form
Maryland Comprehensive Historic Preservation Plan Data
Building 160 - P.G. #67-27
Beltsville Agricultural Research Center
Prince George's County, Maryland

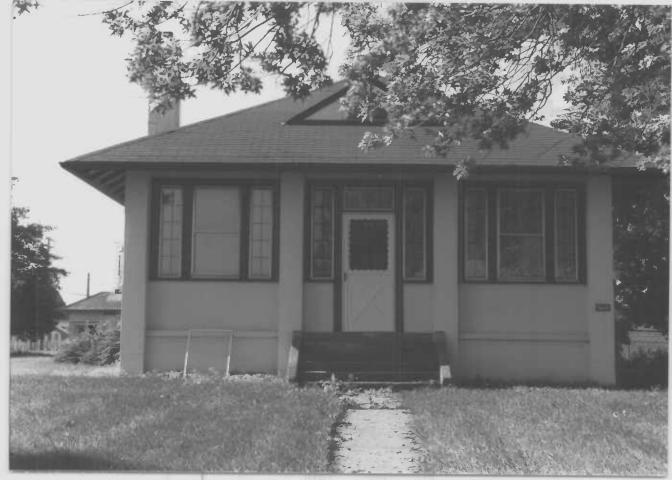
I OF 5

NORTH (FRONT) FACADE LOOKING SOUTH

The principal (north) facade is three bays wide, each of which is delineated by four engaged piers. The upper half of each bay is highlighted by a tripartate fenestration pattern. Located in the center bay, the front door is paneled and has a six-light window. The original door is obscured by a modern metal storm door. An Arts and Crafts-style, vertical, four-light tympanum is placed over the door, and narrow ten-light vertical sidelights flank the door. The two outer bays each feature a large, central, one-over-one, double-hung window, again flanked by narrow ten-light vertical sidelights. A projecting beltcourse emphasizes the level of the raised basement, and aligns with the top step of a flight of five concrete stairs leading to the front door.

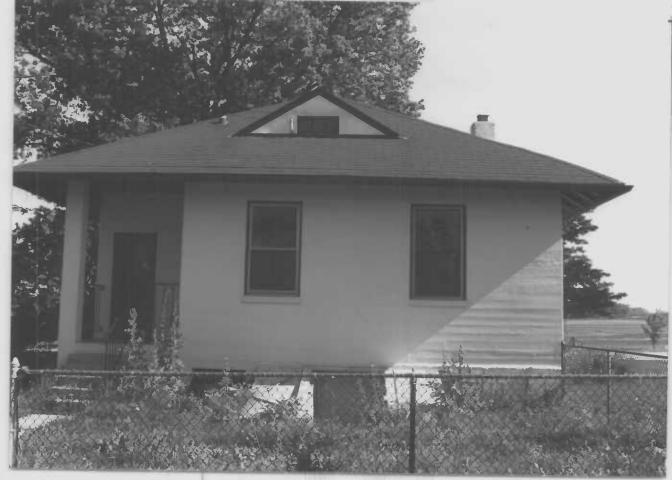
2. OF:5

SOUTH FACADE LOOKING NORTH

The south elevation has a small recessed entry porch at the rear door. A flight of five concrete steps leads to the porch, and the porch and stairs are enclosed by a metal railing. A pier supporting a corner of the hipped roof is located in the southwest corner of the building. Two, large, one-over-one, double-hung windows with simple concrete sills complete this elevation. The raised basement is punctuated by a small single-paned basement window, located adjacent to the rear flight of stairs. A wooden bulkhead door which leads to the basement is centered beneath the two larger windows.

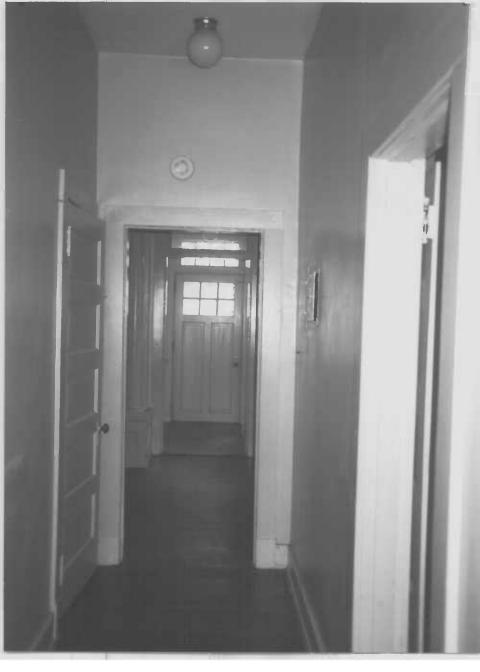
PAIRY BUNGALOW II (BUILDING 160) PG = 67-27 TELTS VILLE AGRICULTURAL RESEARCH CENTER BELTSVILLE, MP PHOTO BY REGINA ARLOTTO, JULY 1996 NEGATIVE AT MP SHPO INTERIOR, VIEW OF FIRST FLOOR HALL LOOKING NORTH 30F 5

A center hall which leads to a bathroom at the rear is entered from the enclosed front porch. A large front room which runs east-west is divided by columns on recessed, raised, paneled blocks. The east end of the room features a brick fireplace surround with brass detailing. Two additional rooms are located on the east

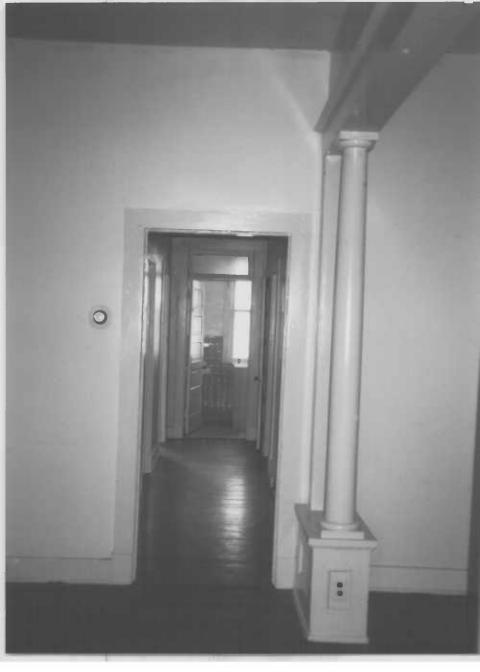
PAIRY BUNGALOW II (BUILDING 160)
PG #67-27
BELTSVILLE AGRICULTURAL RESEARCH
CENTER
BELTSVILLE, MP
PHOTO BY REGINA ARLOTTO, July 1996
NEGATIVE AT MP SHPO
INTERIOR, VIEW OF FIRST FLOOR HALL
LOOKING SOUTH
4 OF 5

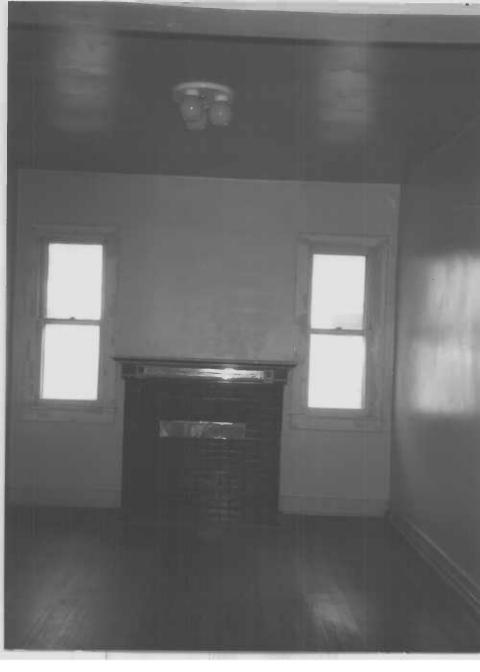
5 OF 5

INTERIOR, VIEW OF FIREPLACE LOOKING WEST
